# POST-REMEDIATION MOLD ASSESSMENT REPORT

Lewis Independent School District  
Huffines Middle School – Server Room  
1440 N. Valley Parkway  
Lewisville, Texas  
Project Number: 01A.1288.008

Re: **Post-Remediation Mold Assessment Report**  
Huffines Middle School – Server Room  
1440 N Valley Parkway  
Lewisville, Texas  
Project Number: 01A.1288.008

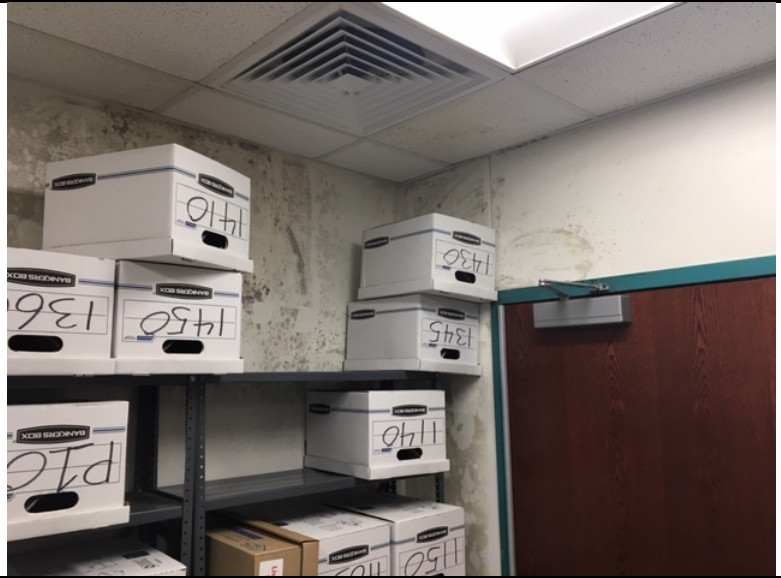
### Photograph 1

View of mold affected materials.

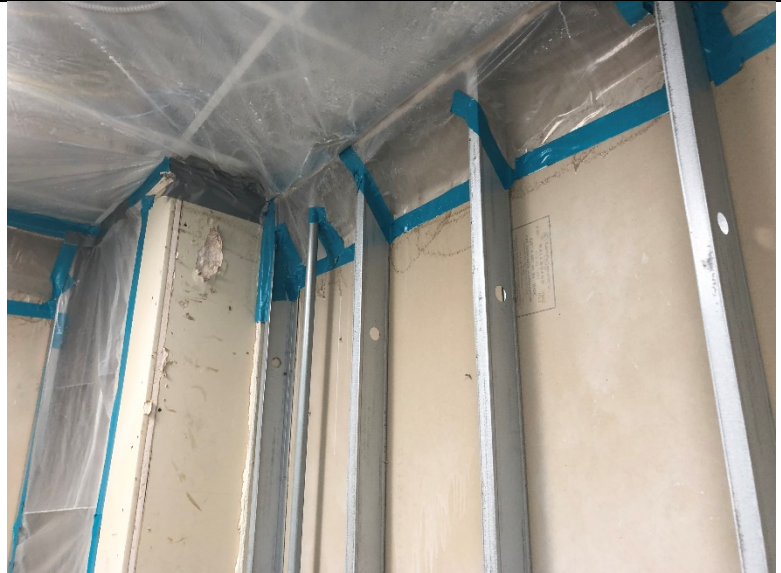
### Photograph 2

Visible investigation of the containments verified that no visible fungal growth or signs of surface fungal contamination were present on the remediated building materials within the containment(s).

View of remediated areas.

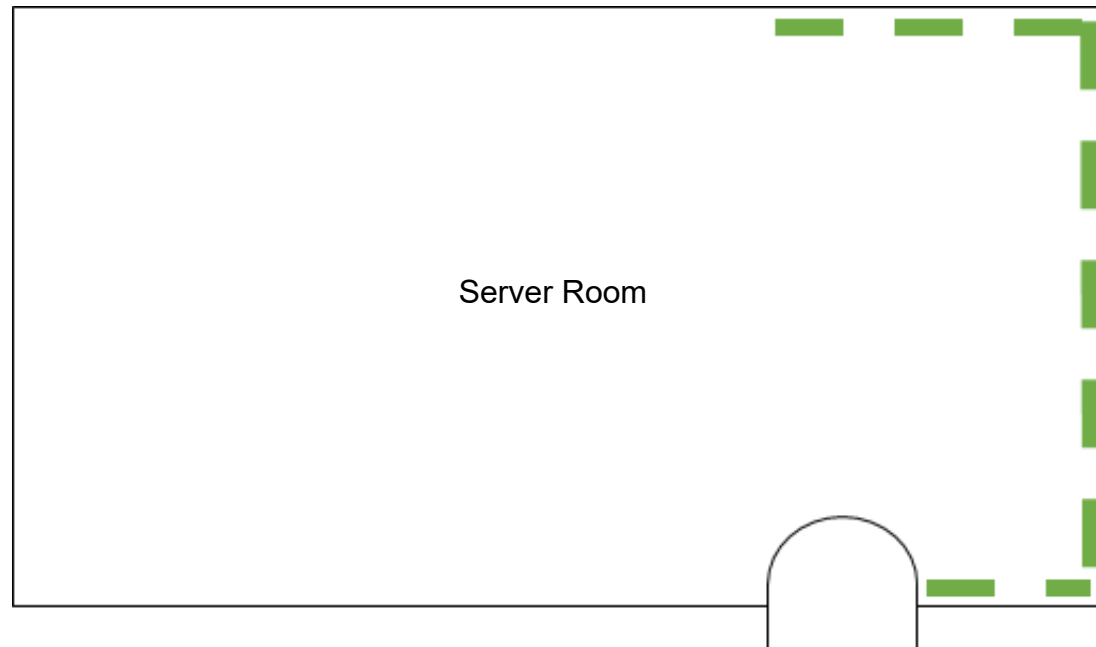
■ ■ ■ Areas with fungal growth
