SUBJECT: LHS Killough - IAQ - Clearance for Remediation - Mechanical Room by Room A123

Re: Post-Remediation Clearance Report
LHS Killough High School
Mechanical Room A123
1301 Summit Avenue
Lewisville, Texas 75077

Apex Project No.: 725010727156

MOLD REMEDIATION PROTOCOL

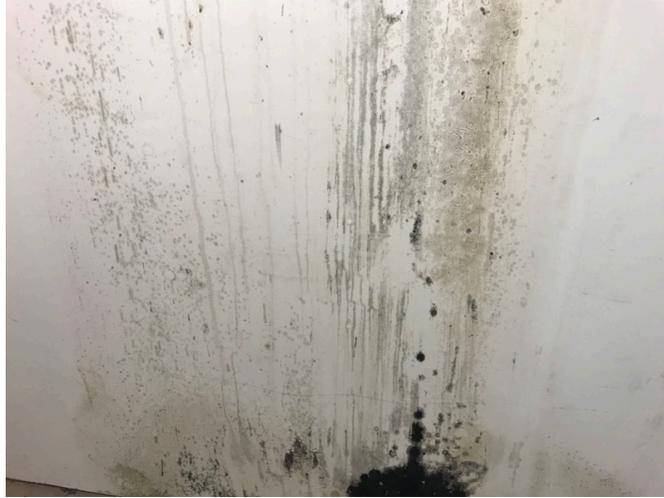
According to information provided by the Client and representatives, it appears that a water leak associated with the HVAC equipment/lines within Mechanical Room A123 has impacted building materials.

Photograph 1
Description: Fungal growth on wall

- Approximately 40 SF** of water-damage/mold growth is assumed behind the walls systems (see attached figure). **Note:** recommend removing wall from floor to ceiling due to the finishing system.

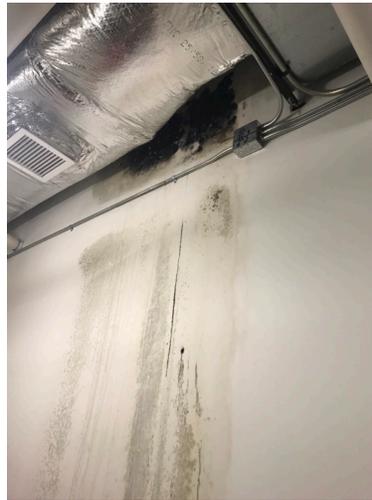
Photograph 2
Description: Fungal growth on wall

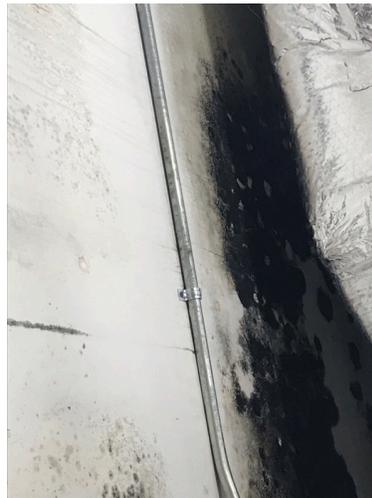
Photograph 3
Description: Fungal growth behind duct on wall

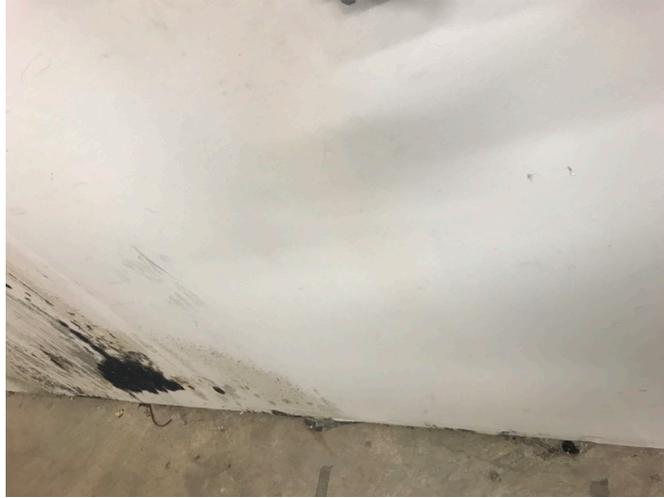
Photograph 4
Description: Fungal growth on wall

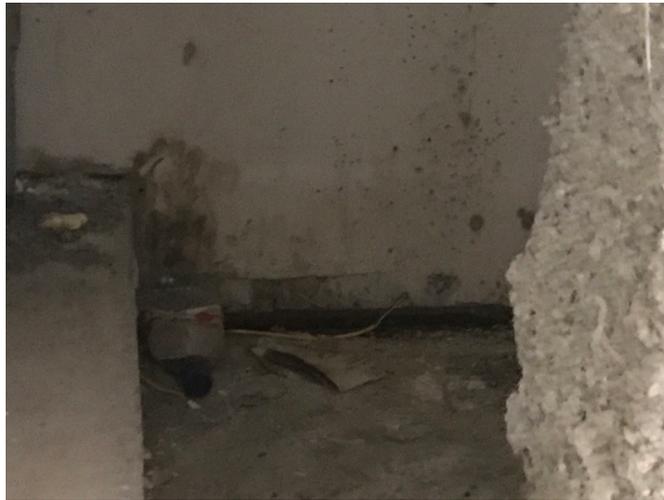
Photograph 5
Description: Fungal growth on wall

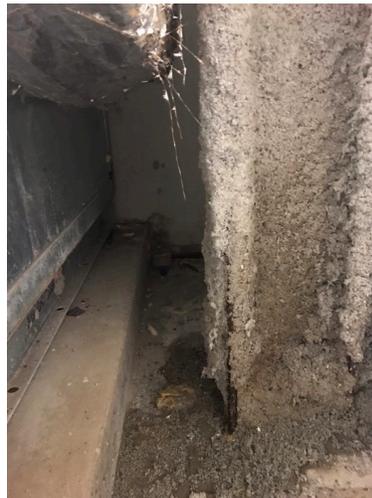
Photograph 6
Description: Fungal growth on wall behind beam

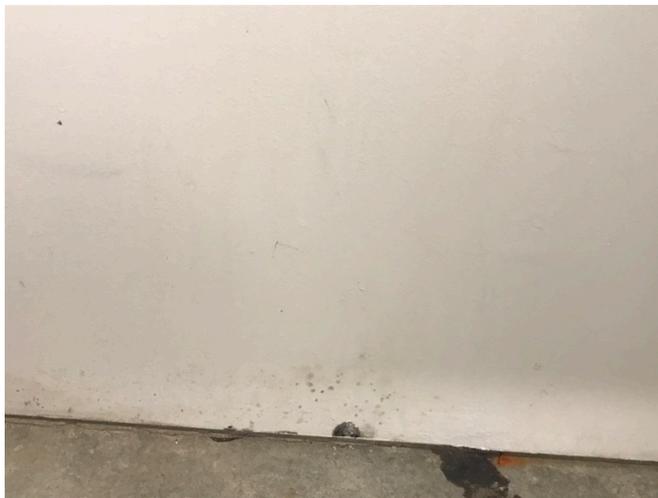
Photograph 7
Description: Fungal growth on wall

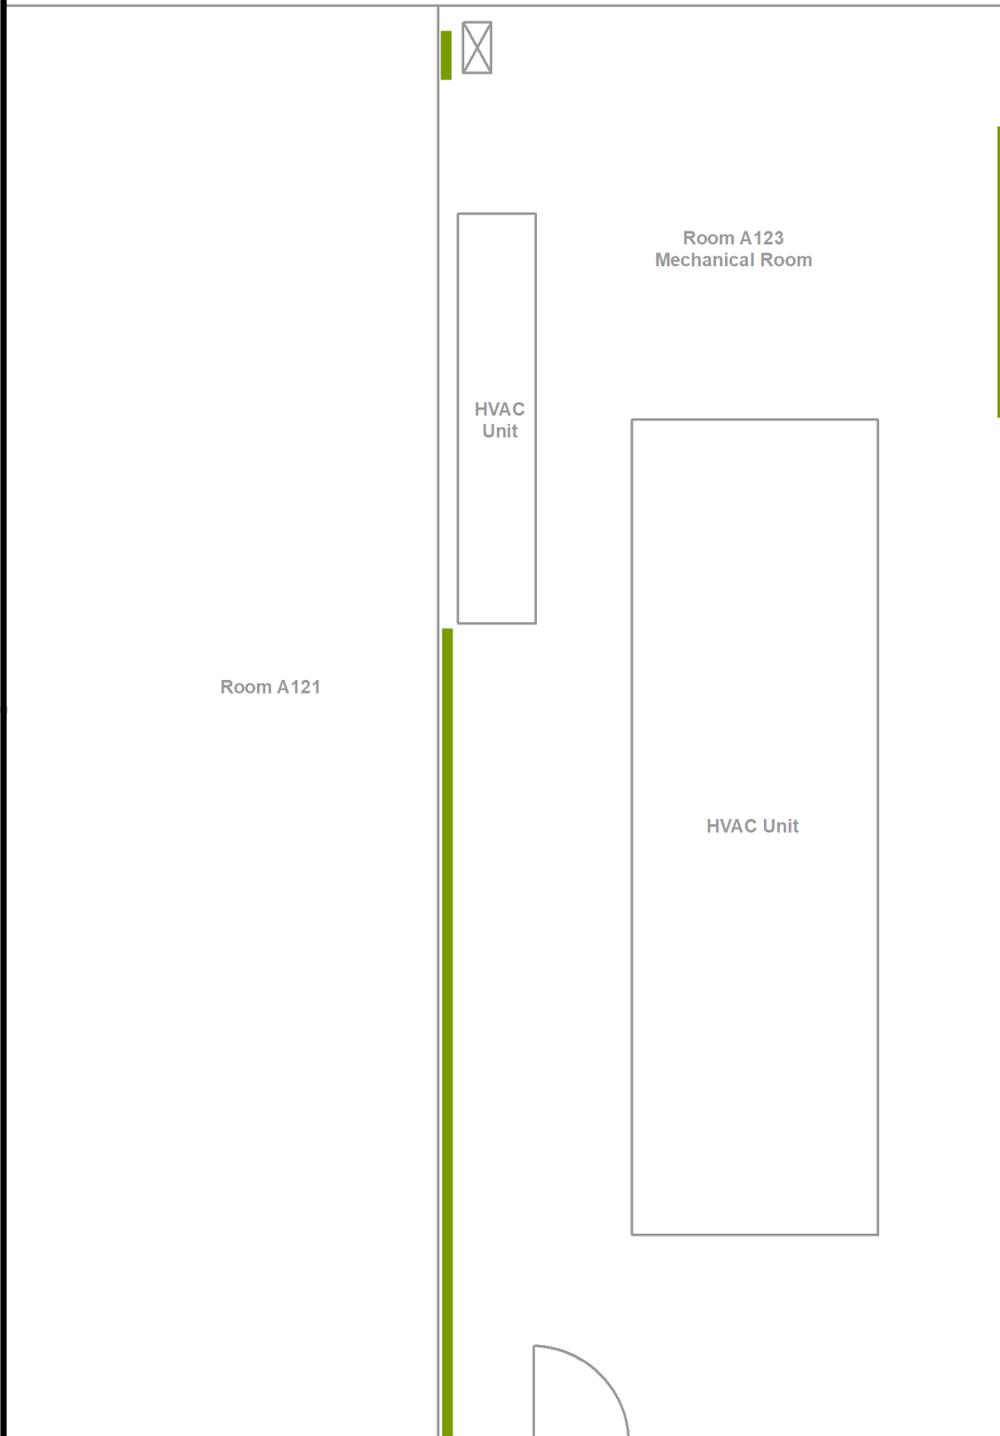
FIGURE 2

Fungal Growth Location Map

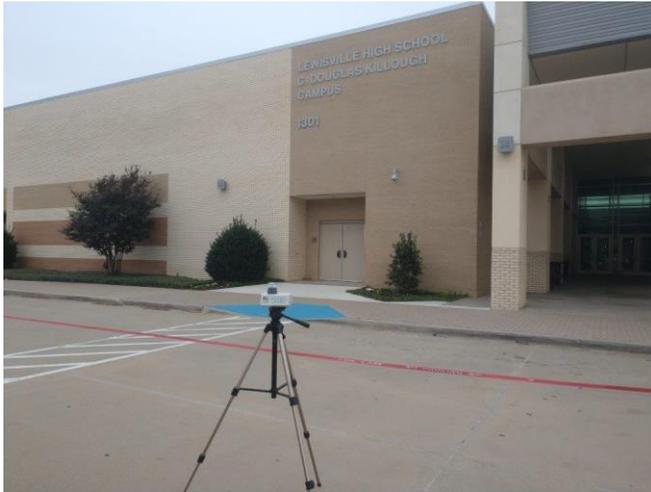
Photograph 1: Air sampling

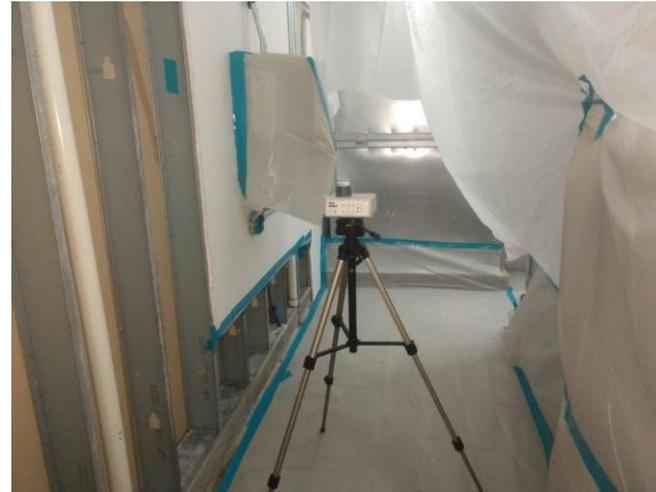
Photograph 2: Air sampling

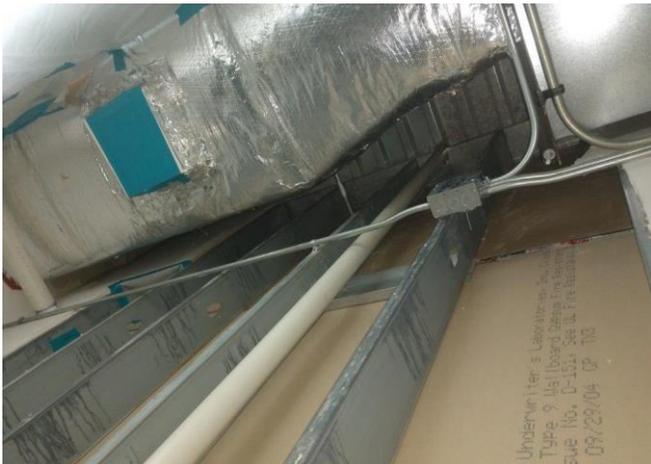
Based on the both inspections, ARC Abatement had removed or remediated all material as noted in the Protocol and Addendum. Apex did not observe any discoloration, accumulation of dust or debris, or suspect mold growth in the remaining areas.

Photograph 3: Inside containment

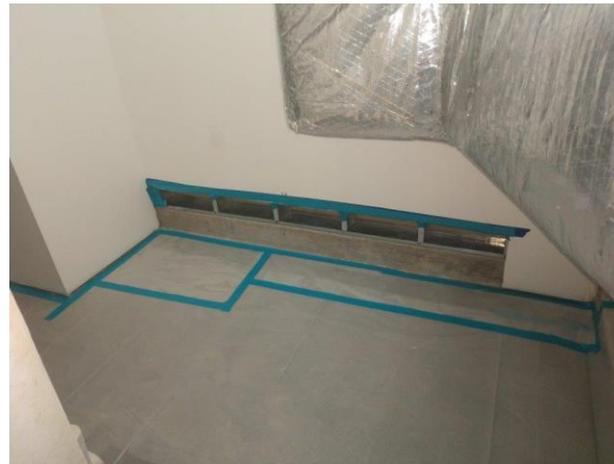
Photograph 4: Inside containment

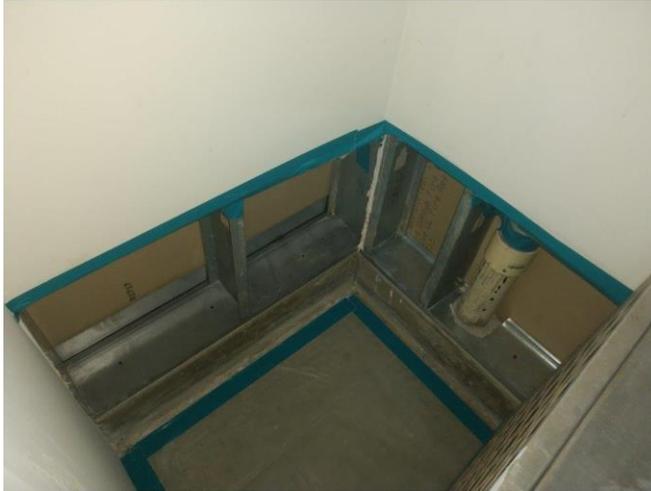
Photograph 5: Inside containment

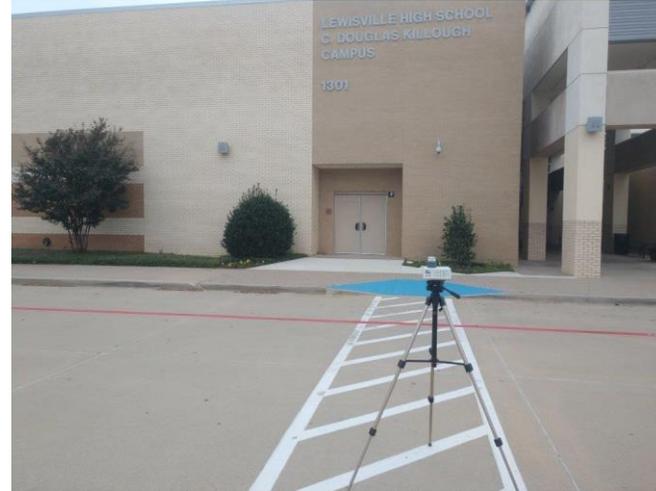
Photograph 6: Air sampling
