SUBJECT: Lakeview MS - IAQ - Air Test Results - Rooms 121 & 213

Re: Limited Mold Assessment
Lakeview Middle School
Rooms 121 and 213
4300 Keys Drive
The Colony, Texas 75056
LISD PO No. 91913794-00
Apex Project No. 725010727165

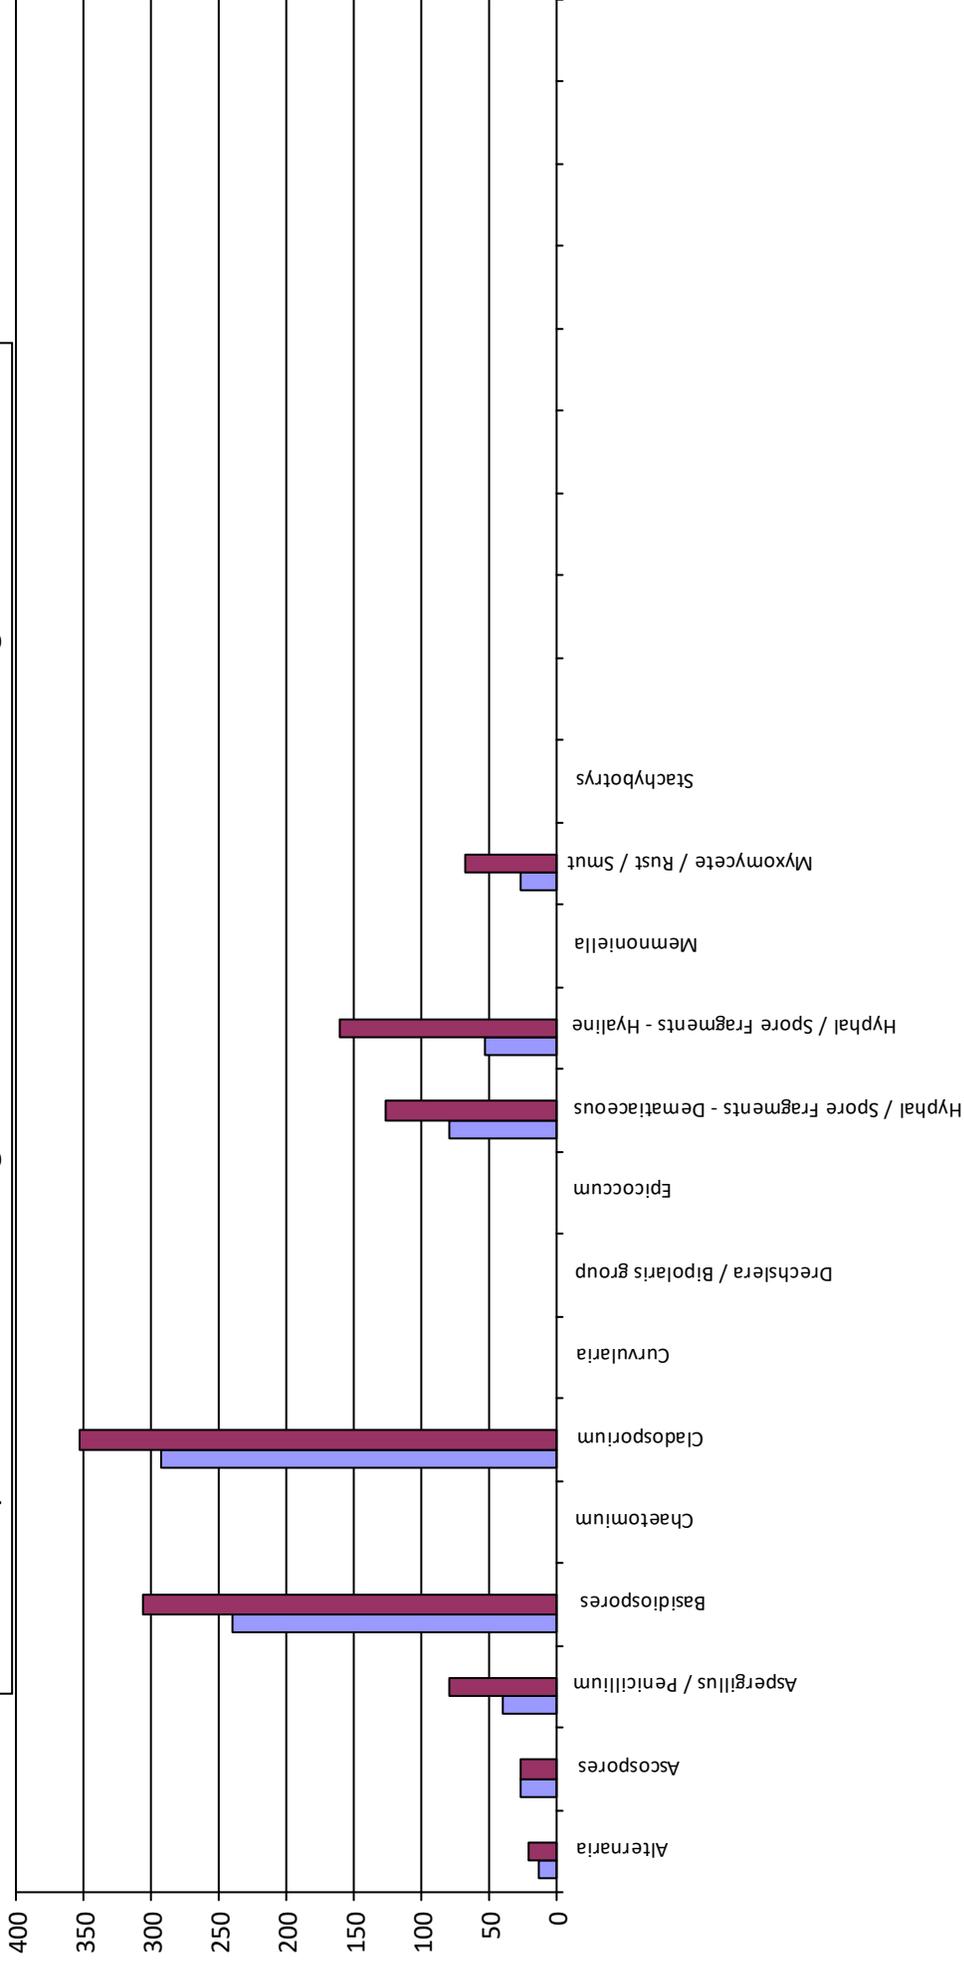
Background / Outside #1

Total airborne mold spores within Room 121 were lower as compared to those measured outside of the building at the time the sampling was performed. The total fungal spore concentration within the class room was reported as 613 spores/m³, while the exterior levels ranged from 773 spores/m³ to 1,480 spores/m³.

Air testing performed using spore traps indicated that total airborne mold spores within Room 213A were lower as compared to those measured outside of the building at the time the sampling was performed. The total fungal spore concentration within the class room was reported as 585 spores/m³, while the exterior levels ranged from 773 spores/m³ to 1,480 spores/m³.

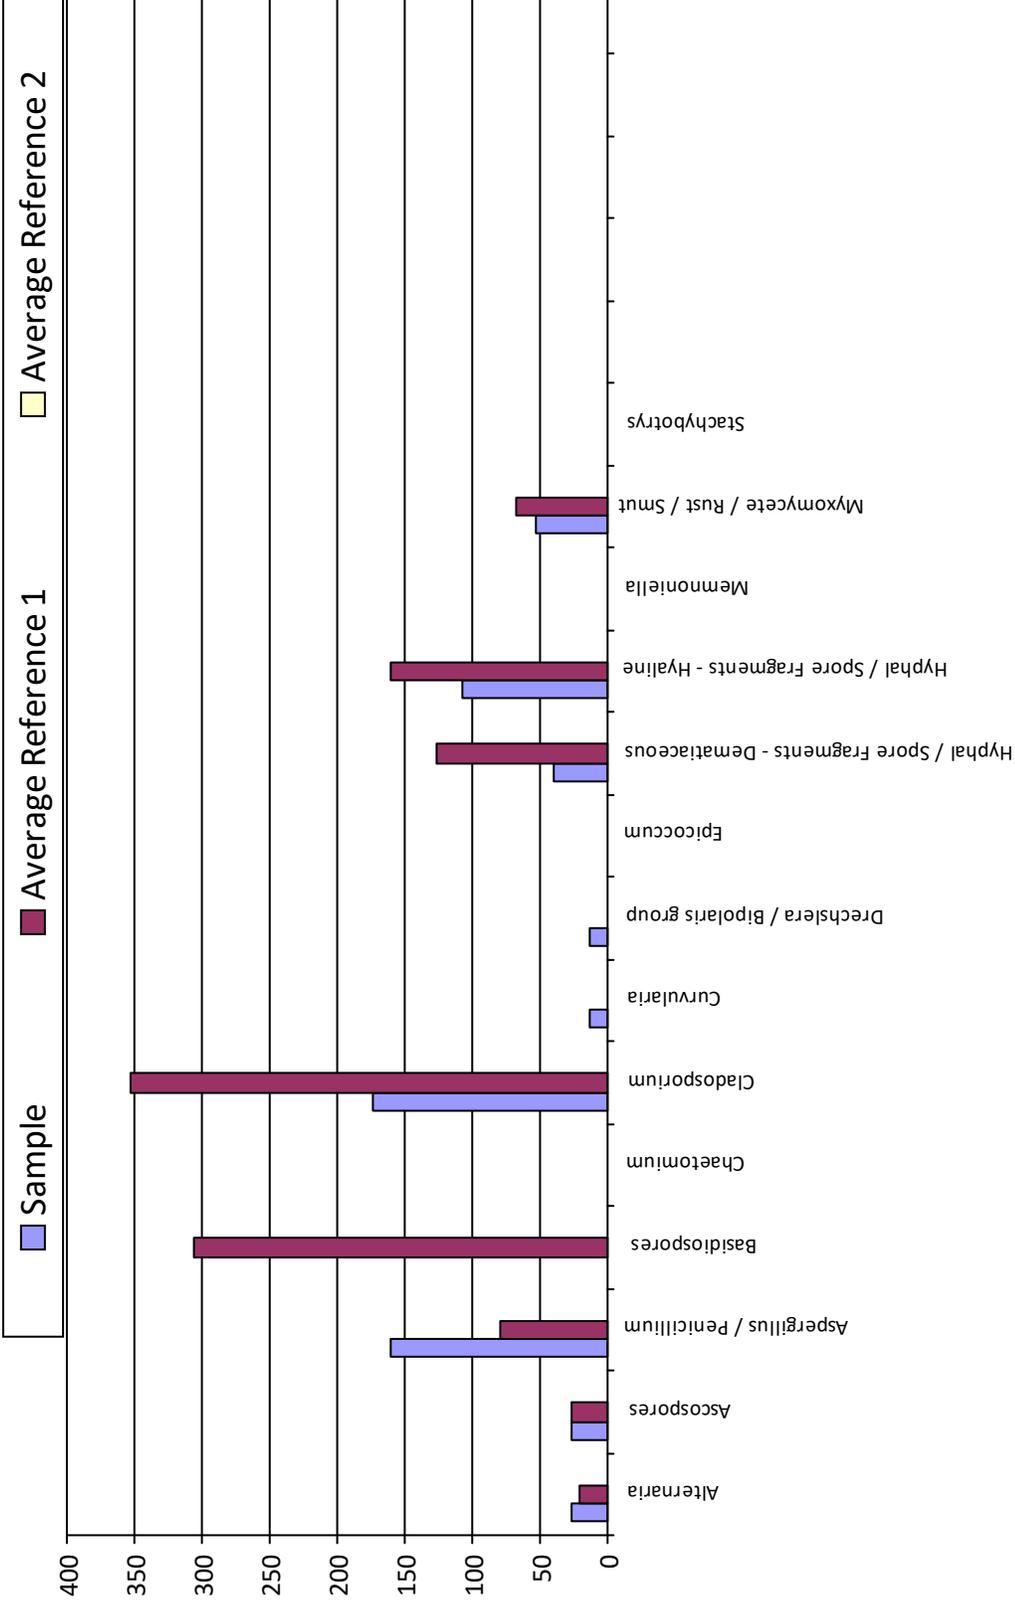
Area, Room 121

Air testing performed using spore traps indicated one (1) type of mold was identified at a slightly higher concentration within the Room 121 as compared to the samples collected from the outside the building. Air sample(s) collected within the Room 121 reported Aspergillus/Penicillium as 160 counts/m³ while exterior levels were reported as 120 counts/m³.

Due to the presence of slightly elevated counts of Aspergillus/Penicillium in Room 121, Apex recommends that Room 121 be cleaned or air scrubbers be installed for a period of at least 24 hours and follow-up samples be collected.
