From: Treadway, David
Sent: Wednesday, May 5, 2021 9:25 AM
To: Garrison, Heather; Jennings, Cory; Cleburn, Gerrod
Cc: Cushing, Belinda; Hughes, Jason; Cashman, Jinger
Subject: Limited Mold Assessment -Lions Den

Re:
Limited Mold Assessment
Griffin Middle School – Lion's Den
5105 North Colony Road
The Colony, Texas
Ensolum Project No. 01A1288133

1.0 INTRODUCTION

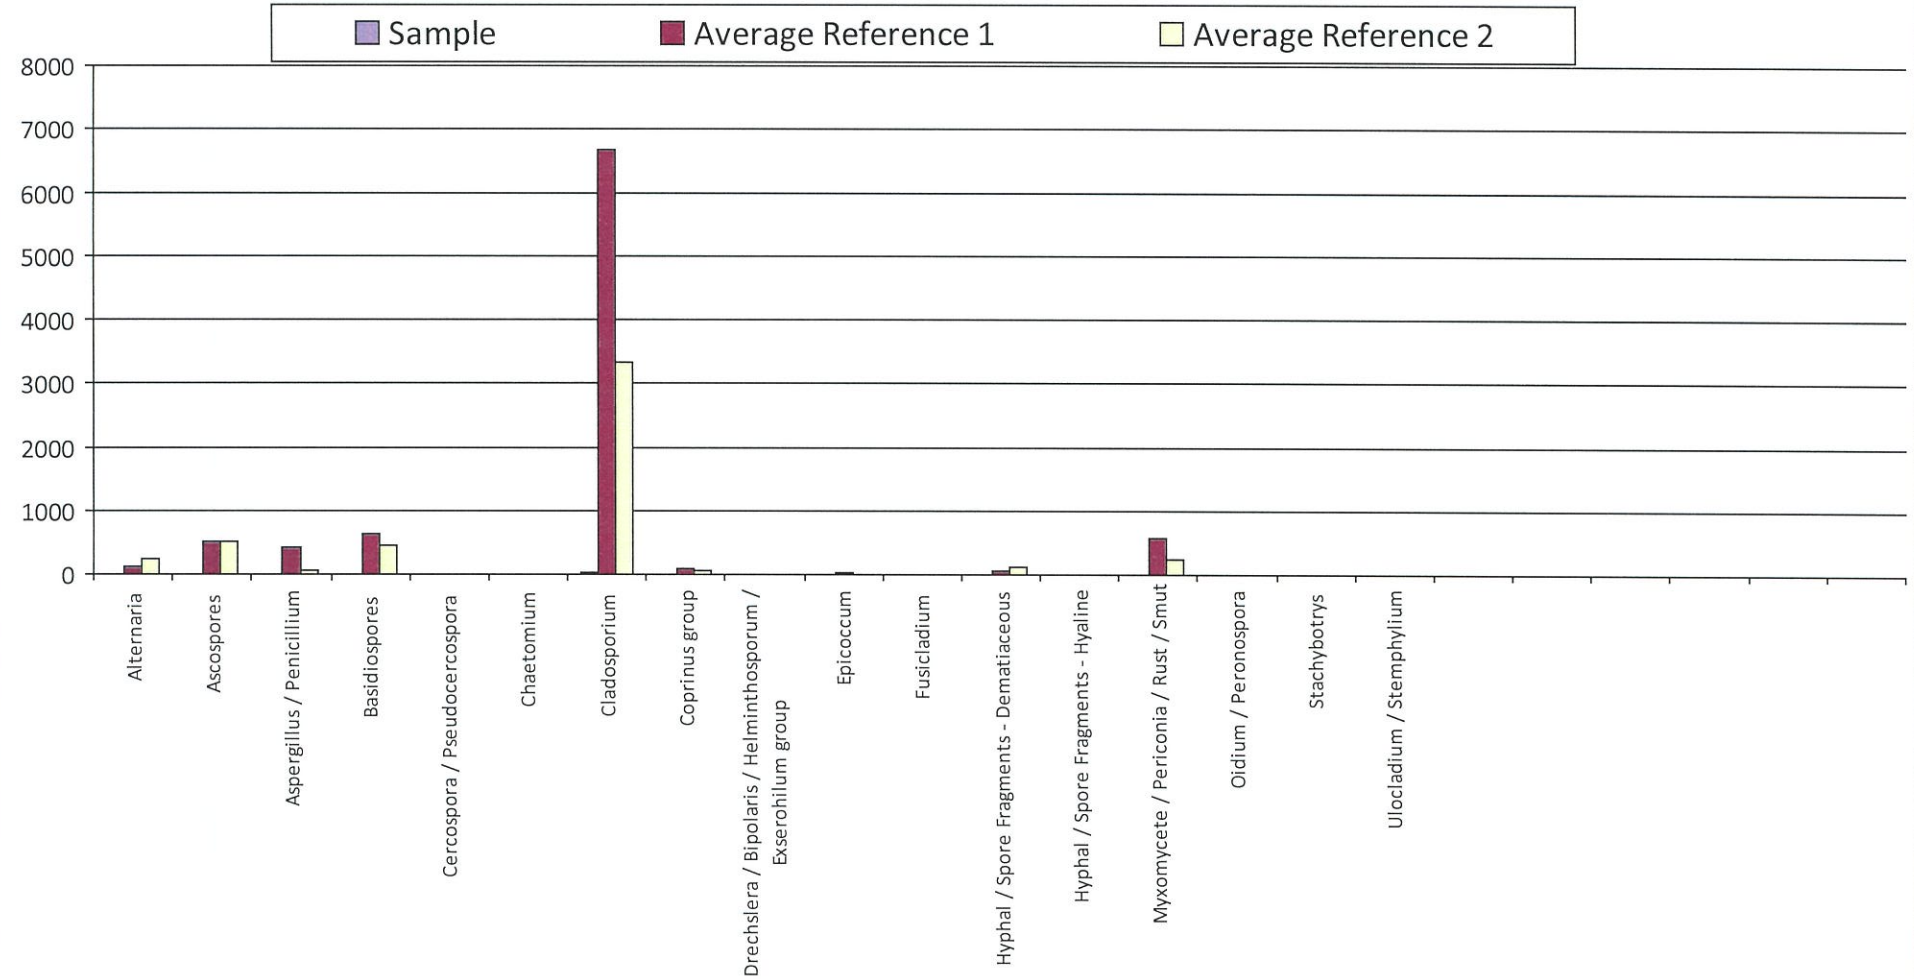
Room - Lion's Den

The results of the fungal air samples collected were evaluated. Air testing performed using spore traps found that airborne mold spores within the rooms were considerably lower and were qualitatively similar to those measured outside of the building at the time the sampling was performed.

Based on ENSOLUM's limited assessment and the analytical results, it appears that the indoor air quality, as it relates to airborne fungi, was within recommended guidelines on the day of the assessment.
