From: Treadway, David
Sent: Monday, October 19, 2020 9:23 AM
To: Deister, Beri; Malone, Keisha; Jones, Victor
Cc: Powell, Patricia
Subject: Limited Mold Assessment Rm 120

Re:
Limited Mold Assessment
Lakeview Middle School
Room 120
4300 Keys Drive
The Colony, Texas
Ensolum Project No. 01A.1288.104

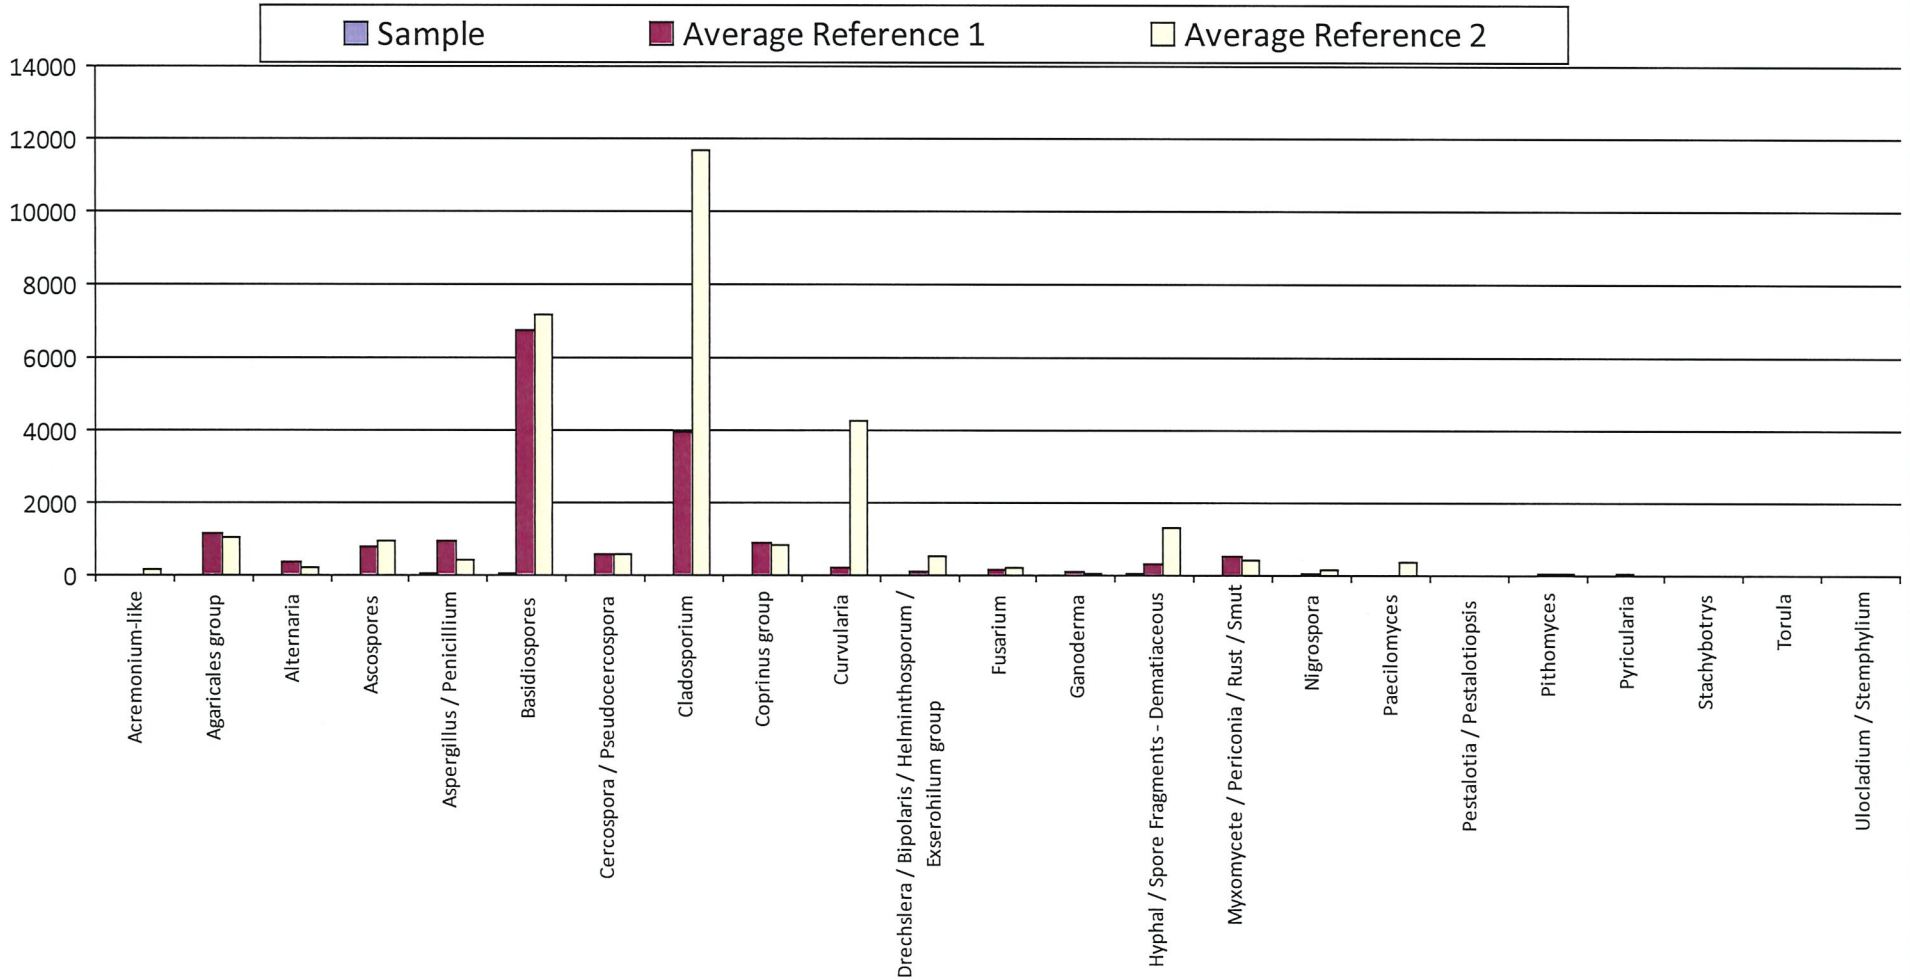
Room 120

The results of the fungal air samples collected were evaluated. Air testing performed using spore traps found that airborne mold spores in the room were considerably lower and were qualitatively similar to those measured outside of the building at the time the sampling was performed.

Based on ENSOLUM's limited assessment and the analytical results, it appears that the indoor air quality, as it relates to airborne fungi, was within recommended guidelines on this day.
