SUBJECT: Lewisville HS - IAQ - Air Test Results - Room G-215, Hallway by
Room G-215, Room G-312 and 3rd Floor Hallway by Stairs & Restroom

Re: Limited Mold Assessment
Lewisville High School
Room G215, Room G312, 2nd Floor Corridor near Room G215,
3rd Floor Corridor near Restrooms and Stairs
1098 West Main Street
Lewisville, Texas 75067
LISD PO No. 91904743-00
Apex Project No. 725010727153

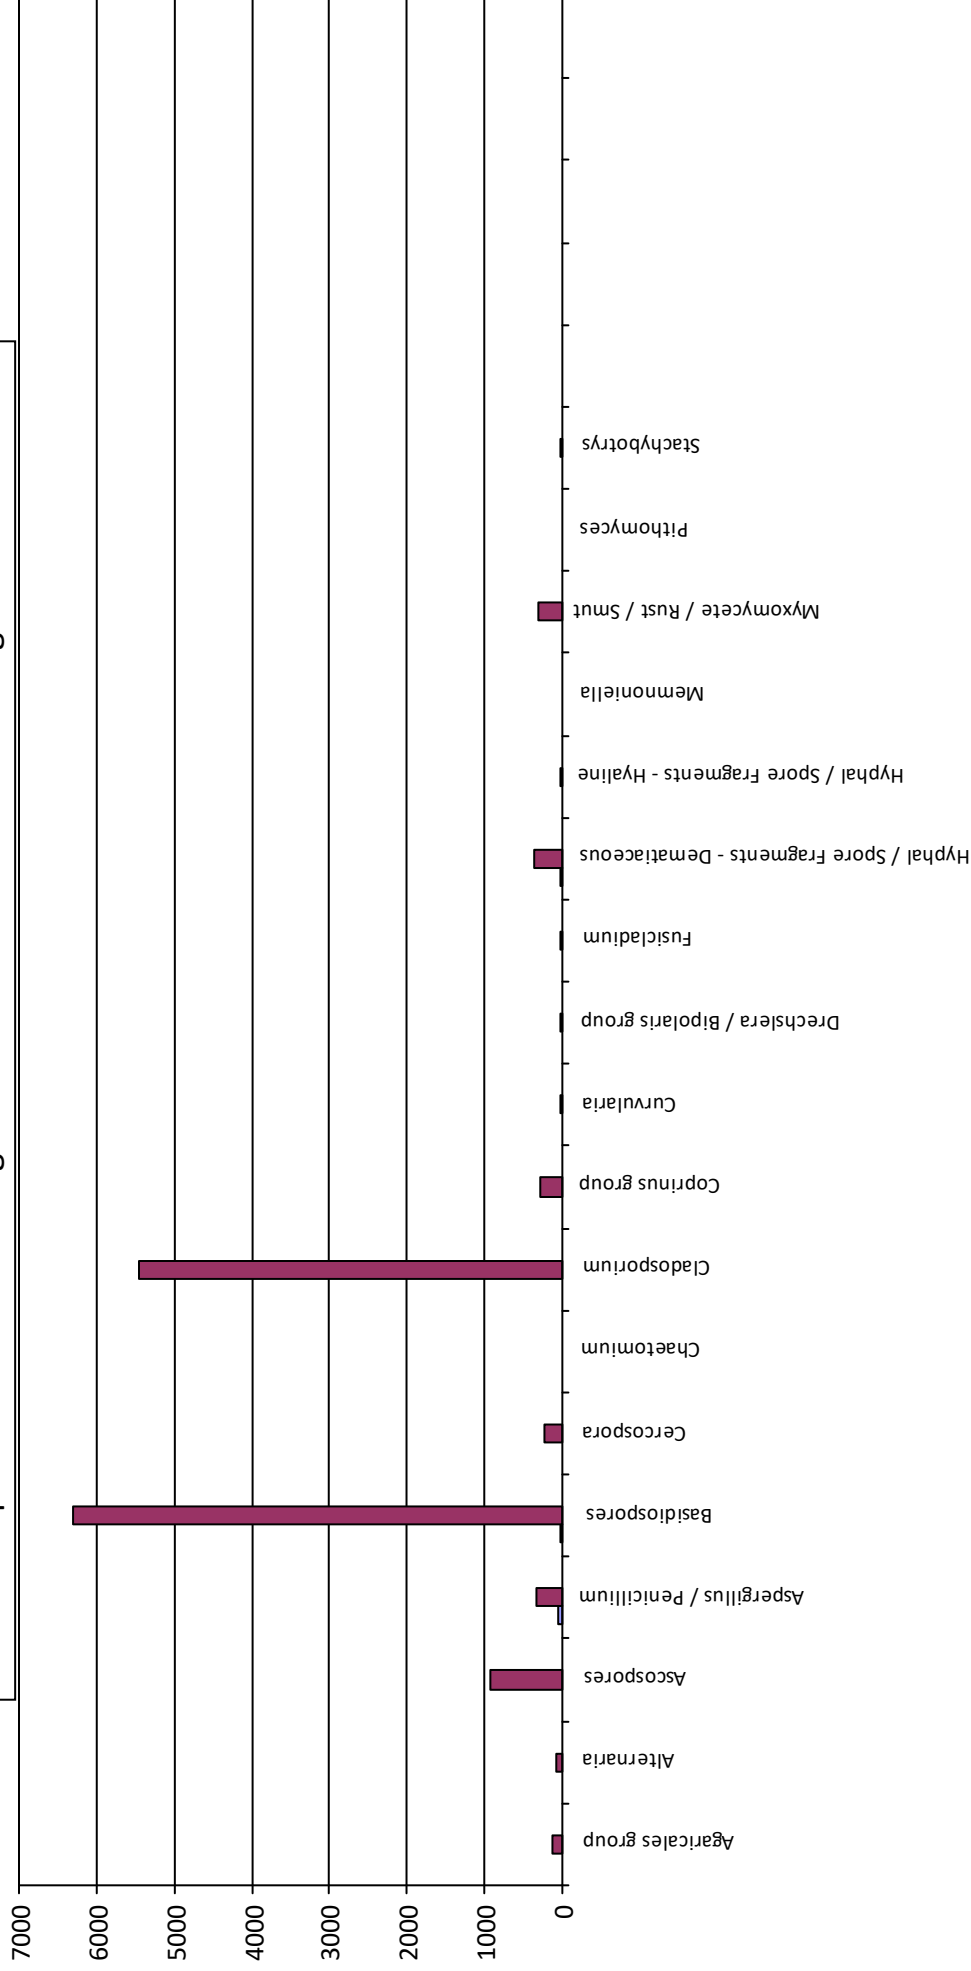
Area, Inside Room G215

Air testing performed using spore traps indicated that total airborne mold spores within Room G215 were lower as compared to those measured outside of the building at the time the sampling was performed. The total fungal spore concentration within the class room was reported as 80 spores/m³, while the exterior levels were reported as 14,487 spores/m³.

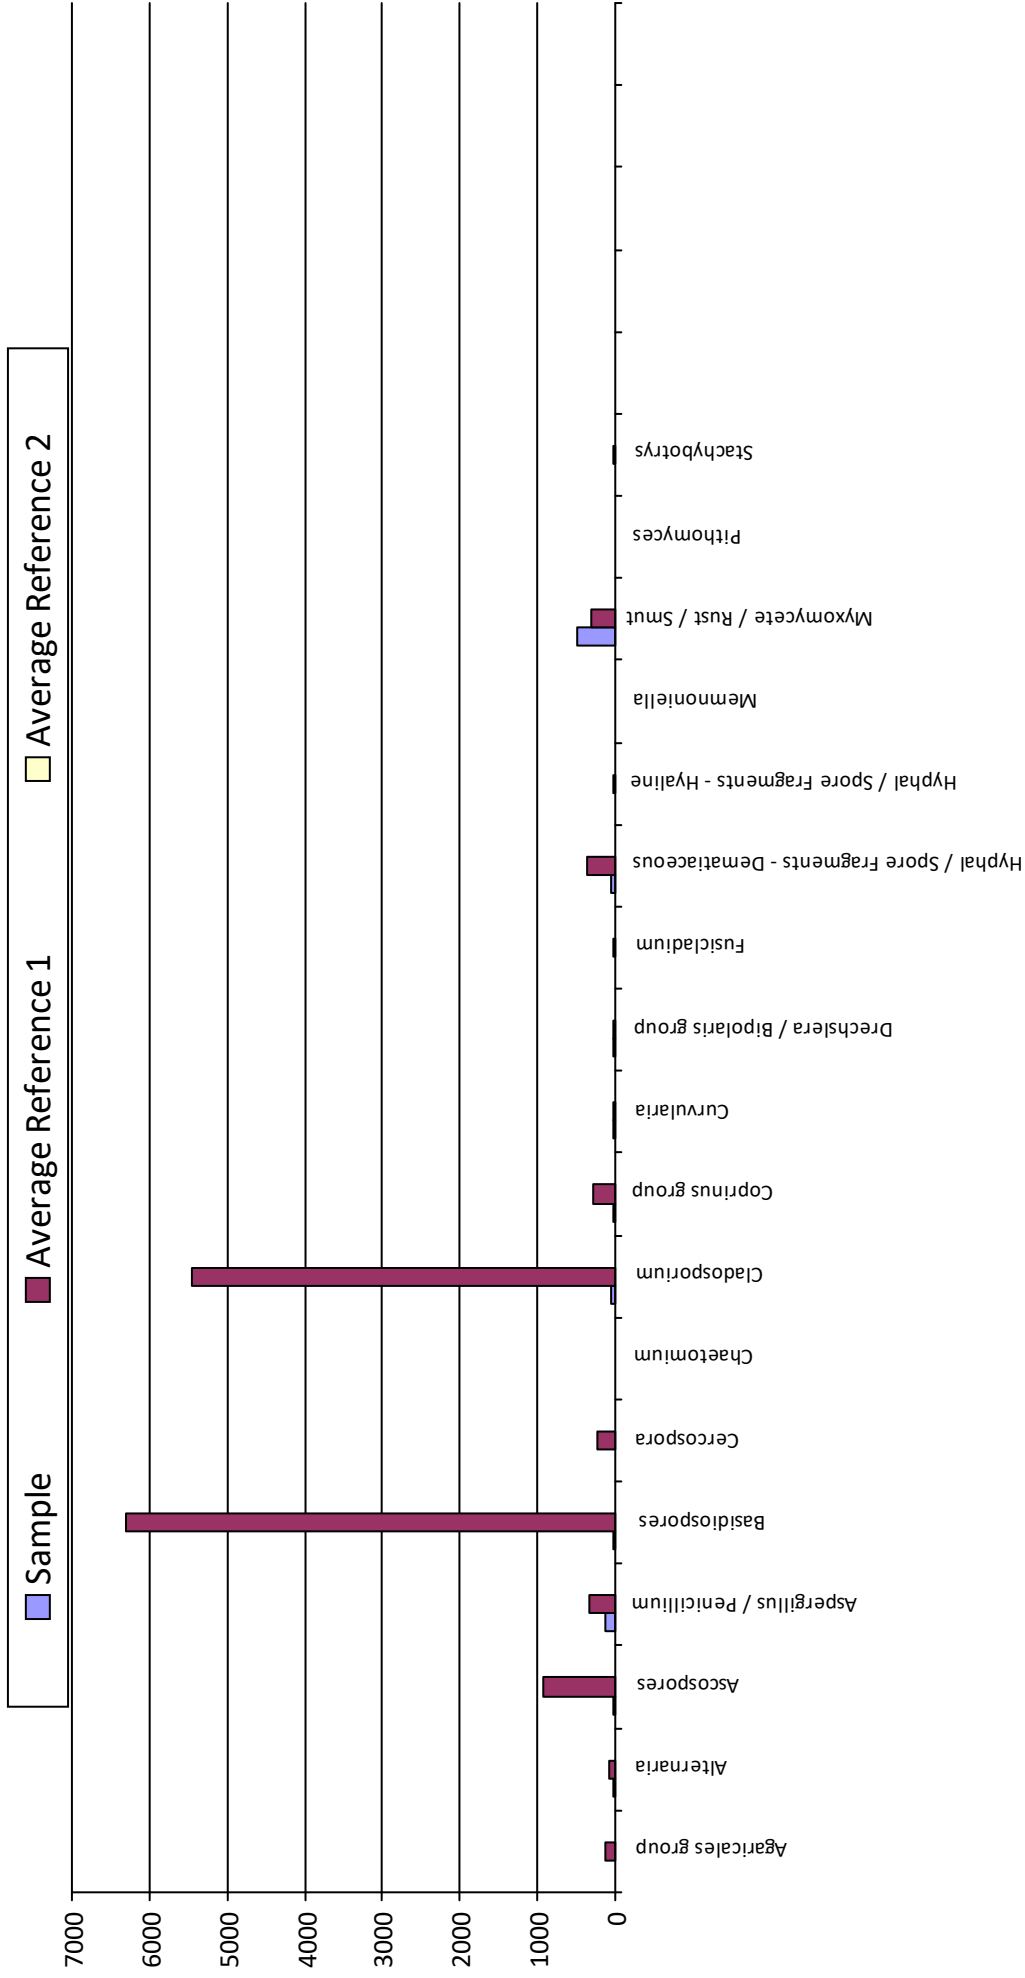
Sample Date : 10/11/2018
Area, 2nd Floor Corridor, Near G215, Under Leak Area from Fall 2017

Air testing performed using spore traps indicated that total airborne mold spores within the 2nd Floor Corridor near Room G215 were lower as compared to those measured outside of the building at the time the sampling was performed. The total fungal spore concentration within the class room was reported as 811 spores/m³, while the exterior levels were reported as 14,487 spores/m³.

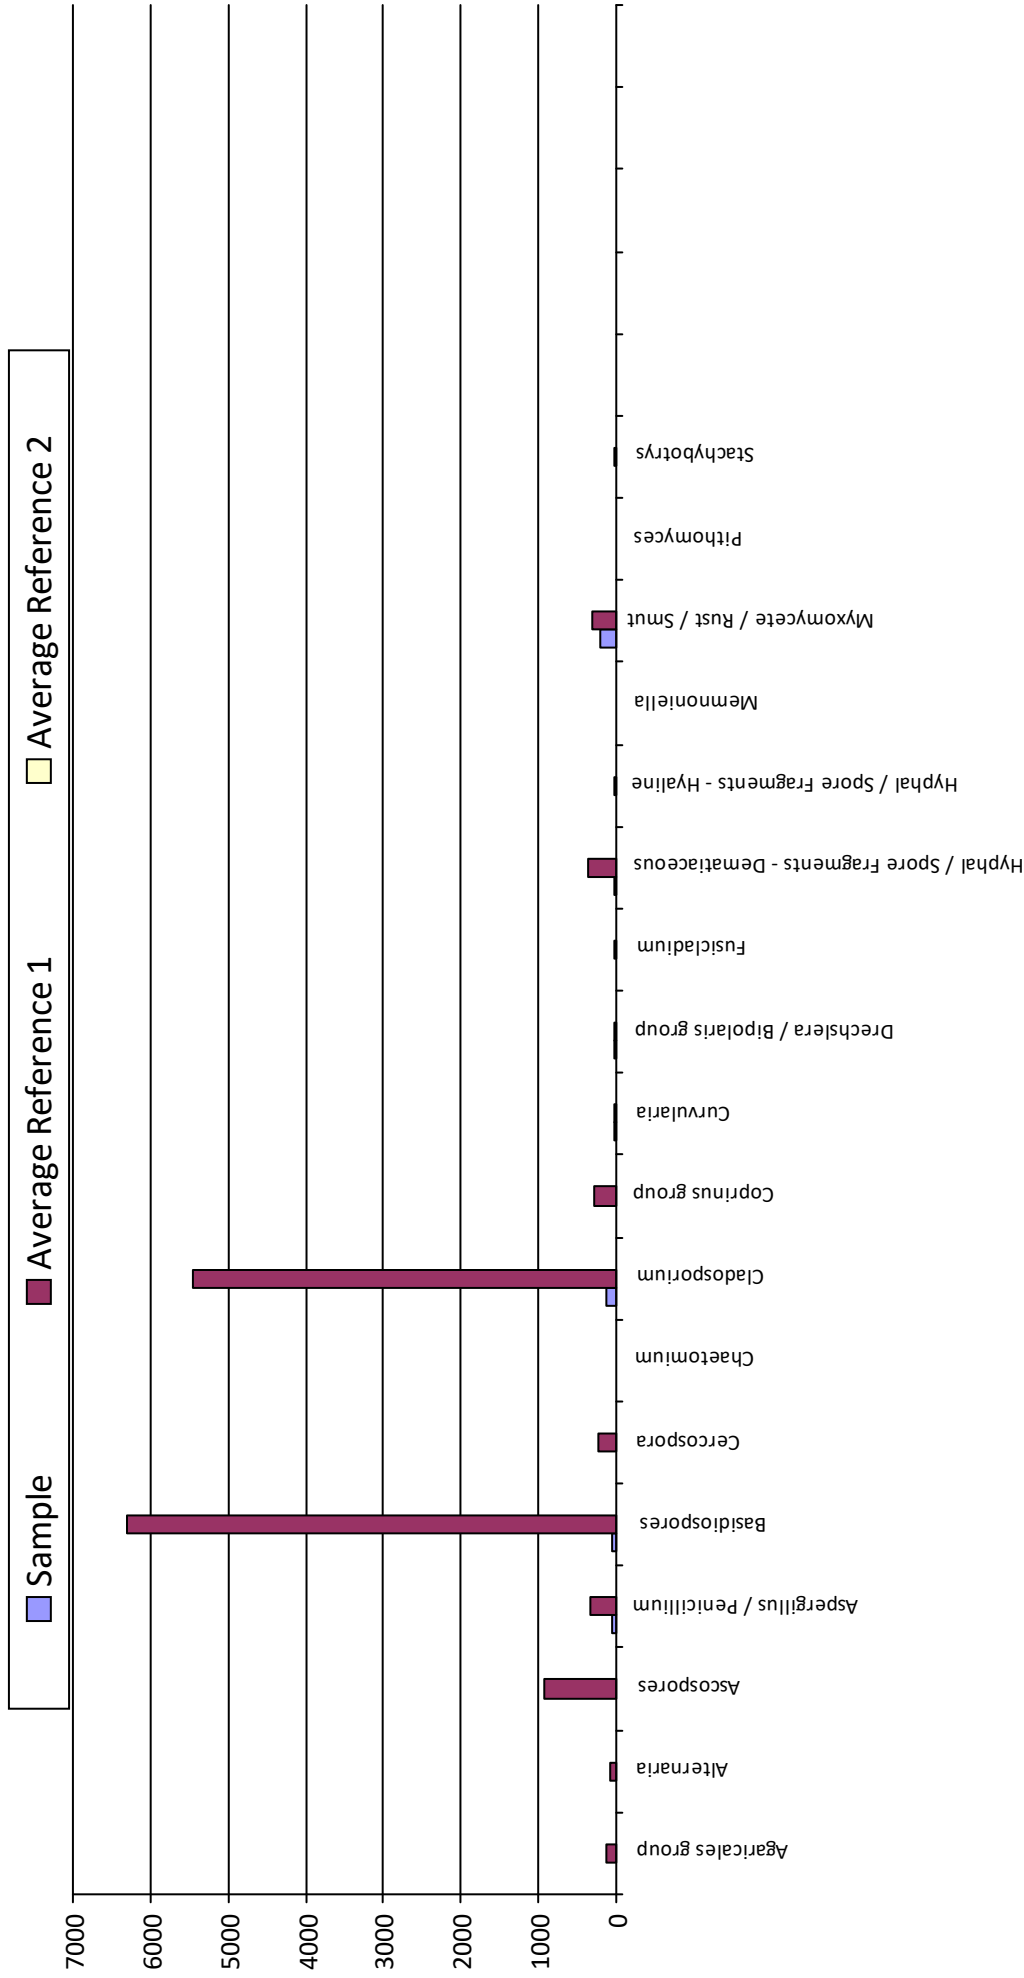
Area, Inside Room G312, Under Leak Area from Spring 2018

Air testing performed using spore traps indicated that total airborne mold spores within Room G312 were lower as compared to those measured outside of the building at the time the sampling was performed. The total fungal spore concentration within the class room was reported as 452 spores/m³, while the exterior levels were reported as 14,487 spores/m³.

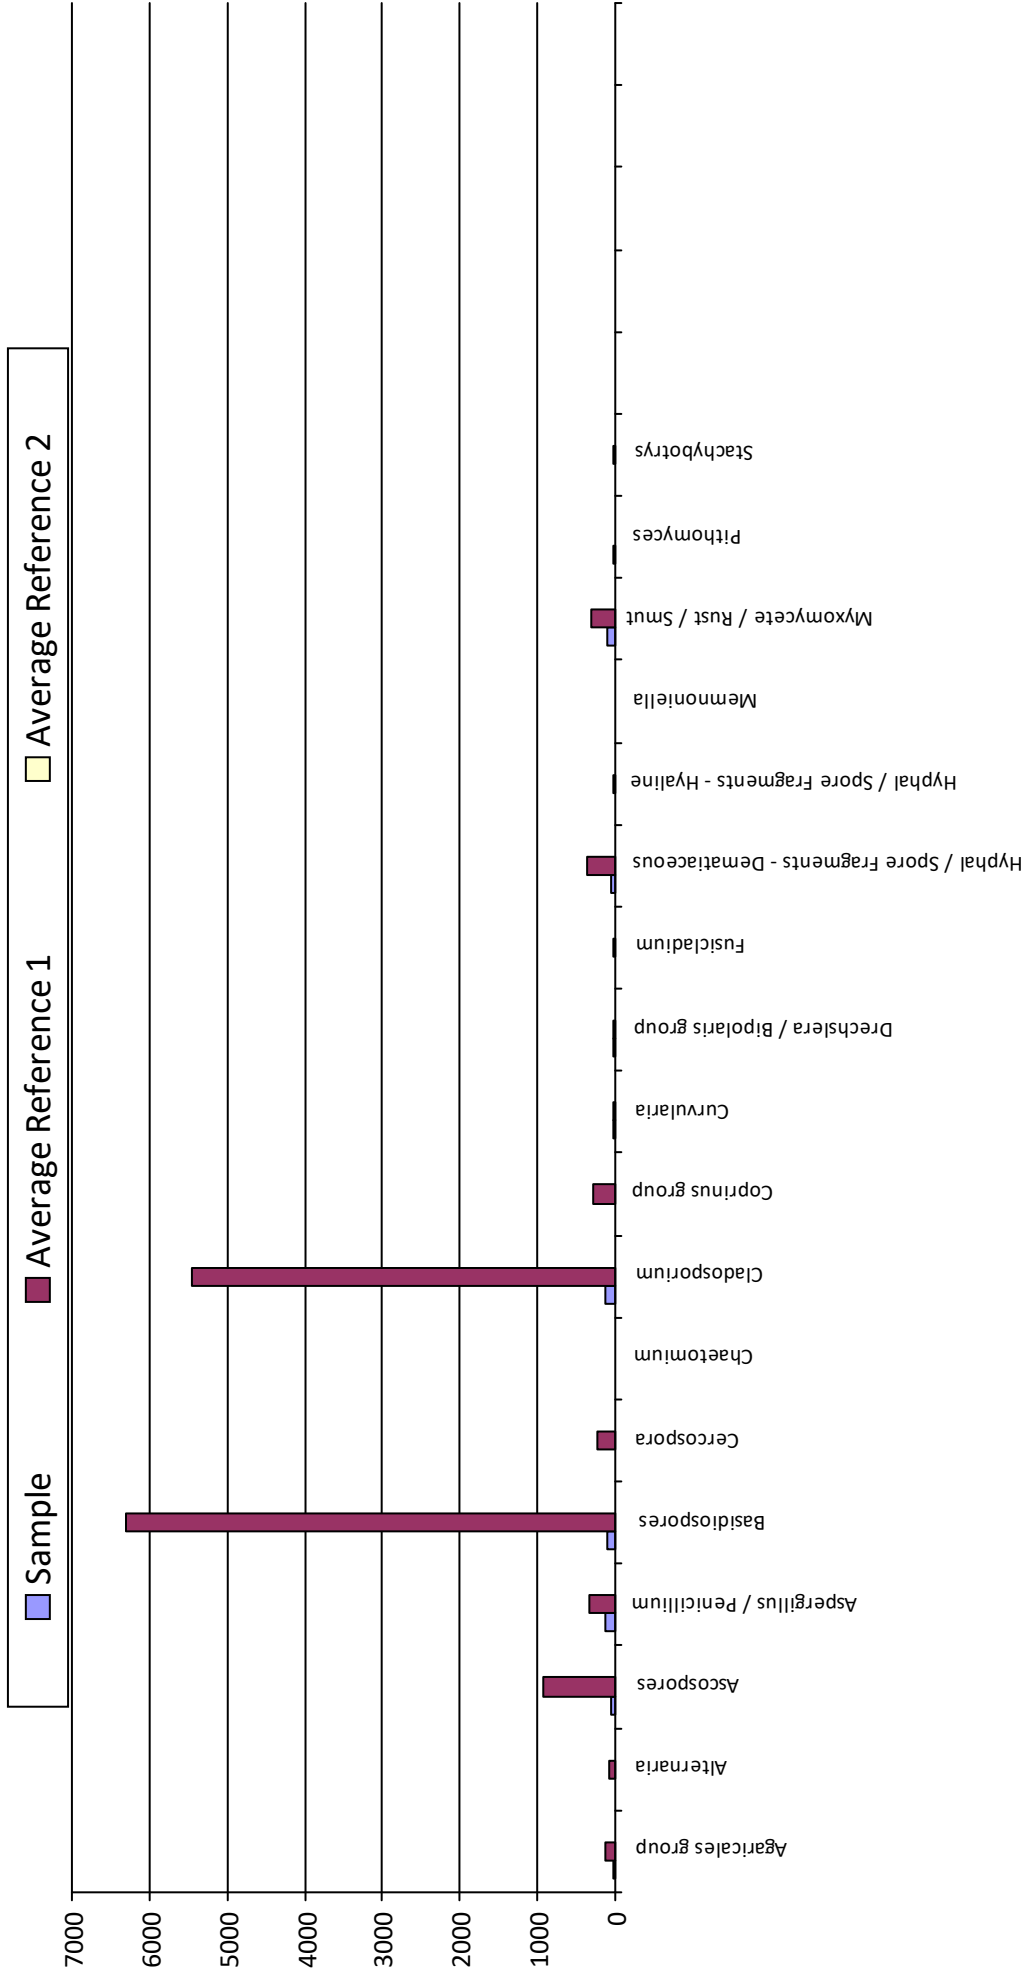
Air testing performed using spore traps indicated that total airborne mold spores within the 3rd Floor Corridor near Restrooms and Stairs were lower as compared to those measured outside of the building at the time the sampling was performed. The total fungal spore concentration

within the class room was reported as 571 spores/m³, while the exterior levels were reported as 14,487 spores/m³.
